Manhole Inspection Summary

Manhole # S2111_004MH

Insp Date: **5/5/08 9:13 AM**

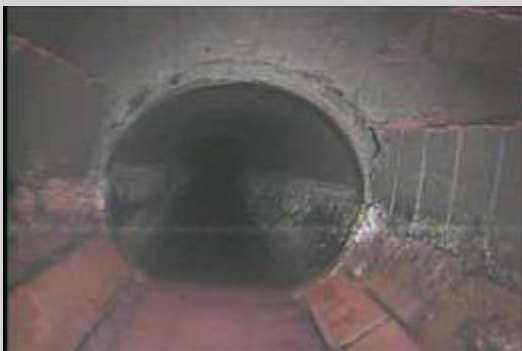
6 O'Clock Inflow

10 in. Circular Gravity Sewer
Pipe In @ 6 O'Clock

Pipe Height: **10.8** (in.) Rod and Bar (Angled)
Pipe Material: **Clay** ☐ Pipe Lined
Invert Depth: **14.94** (ft.) Flow Characteristics: **Slow**
Deposits: ☒ None ☐ Mud ☐ Sludge ☐ Debris ☐ Grease
Silt Depth: **0** (in.) Deposits Extent:
Infiltration: **None** Pipe Seal Cond: **Sound**
